**DEPARTMENT OF TRANSPORTATION**

Quality Assurance and Source Inspection

Contract #: 04-0120F4Cty: SF/ALA Rte: 80 PM: 13.2/13.9File #: 69.28**WELDING INSPECTION REPORT****Resident Engineer:**Pursell, Gary**Address:** 333 Burma Road**City:** Oakland, CA 94607**Report No:** WIR-014272**Date Inspected:** 26-Apr-2010**Project Name:** SAS Superstructure**OSM Arrival Time:** 700**Prime Contractor:** American Bridge/Fluor Enterprises, a JV**OSM Departure Time:** 1900**Contractor:** Zhenhua Port Machinery Company, Ltd (ZPMC), Changxing Island **Location:** Shanghai, China**CWI Name:** Li Yang**CWI Present:** Yes No**Inspected CWI report:** Yes No N/A**Rod Oven in Use:** Yes No N/A**Electrode to specification:** Yes No N/A**Weld Procedures Followed:** Yes No N/A**Qualified Welders:** Yes No N/A**Verified Joint Fit-up:** Yes No N/A**Approved Drawings:** Yes No N/A**Approved WPS:** Yes No N/A**Delayed / Cancelled:** Yes No N/A**Bridge No:** 34-0006**Component:** Orthotropic Box Girder( OBG)**Summary of Items Observed:**

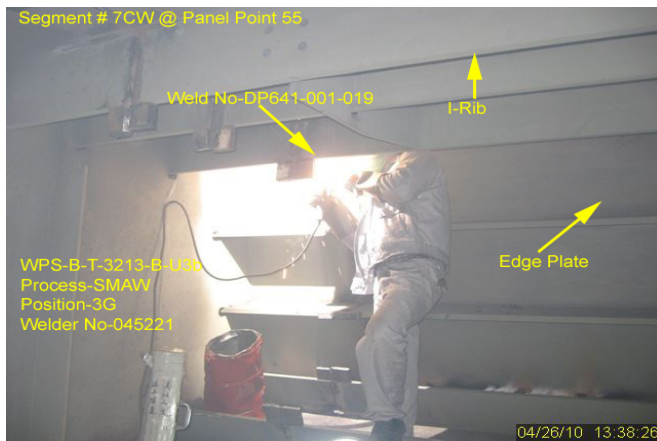
### Segment # 7CW-PP55

This QA inspector observed, ZPMC qualified welding personnel identified as 045221 perform Shielded Metal Arc Welding (SMAW), weld joint identified as DP641-001-019; ZPMC QC is identified as Mr. Wang Li Yang. The welding parameters measured using QC's calibrated instrument appeared to be in general compliance with WPS-B-T-3213-B-U3b. See the attached below Photo.

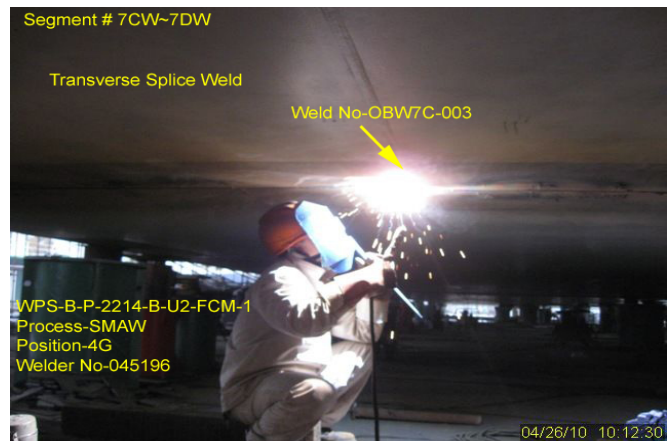
### Segment # 7CW~7DW

This QA inspector observed, ZPMC qualified welding personnel identified as 045196 perform Shielded Metal Arc Welding (SMAW), weld joint identified as OBW7C-003; ZPMC QC is identified as Mr. Wang Zhu. The welding parameters measured using QC's calibrated instrument appeared to be in general compliance with WPS-B-P-2214-B-U2-FCM-1. See the attached below Photo.
